A STUDY OF HIGH POWER ARGON LASER OPTICS

FINAL REPORT

Contract NAS 12-548

RAYTHEON COMPANY
Research Division
Waltham, Massachusetts

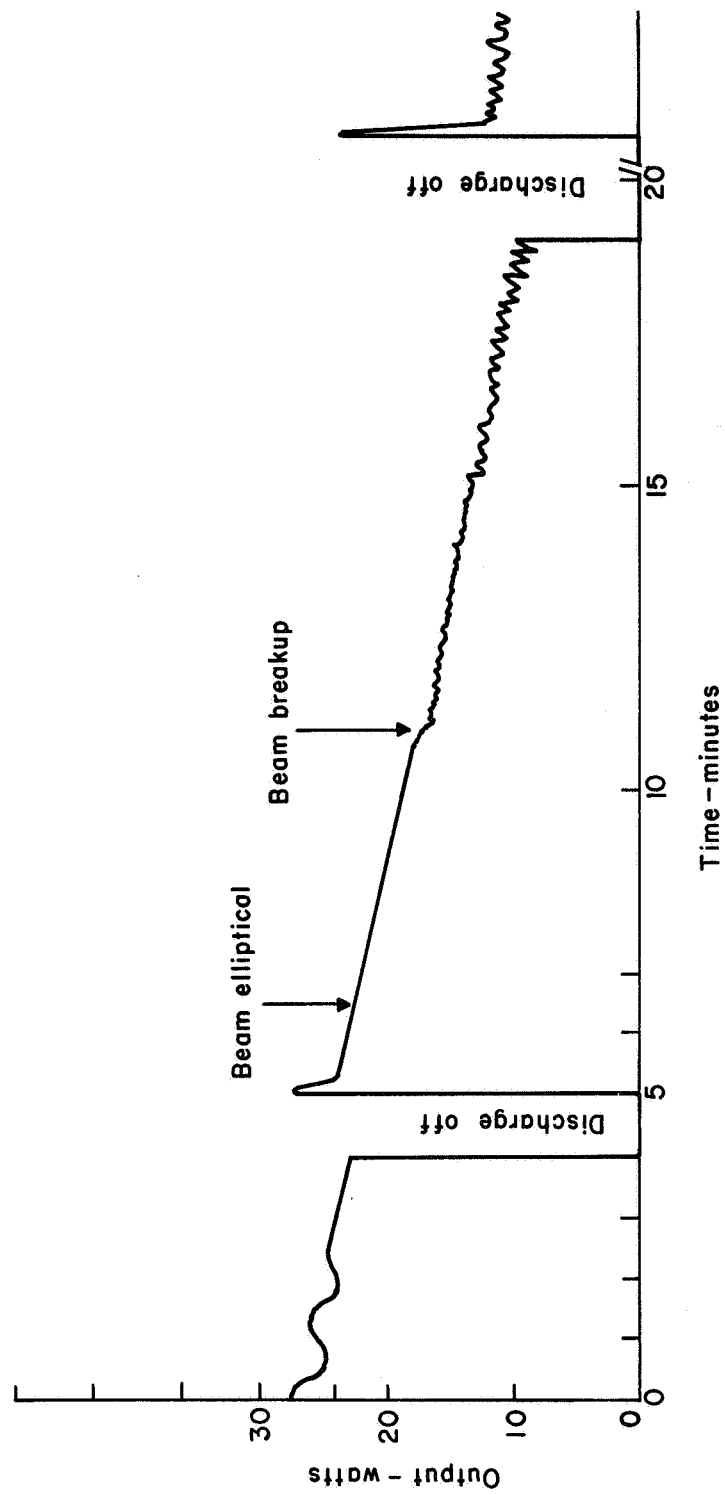
FIGURE 1

Even more troublesome were the power-limiting effects encountered when a Brewster-angle window was used at the termination. In this case, laser output was found to decay with time at a rate which varied with the level of operation: the higher the current, the faster the decay. Figure 1 illustrates the decay in output power observed when such a configuration was employed with a large bore (8mm) quartz discharge tube. A shrinking of the beam size and a change in mode configuration were observed to be coincident with this power decay. These changes occurred in a regular sequence: an initial reduction in beam diameter was followed by a shift from circular to elliptical cross section as shown in Fig. 2, photos 1 - 3. As is shown in photos 4 - 6, further beam shrinkage continued until a series of abrupt changes in mode geometry occurred; these are noted on the plot in Fig. 1 as "beam breakup." Eventually an equilibrium condition would be established in which both the output power and beam area were only a fraction of the original values. If lasing were interrupted at this point by masking one of the mirrors and later resumed, a rapid re-enactment of the above-described cycle ensued, as depicted in that portion of the plot in Fig. 1 beyond the 20-minute mark.

TYPICAL DECAY OF OUTPUT POWER DUE TO WINDOW DEGRADATION. DISCHARGE CURRENT IS 70 AMPERES.

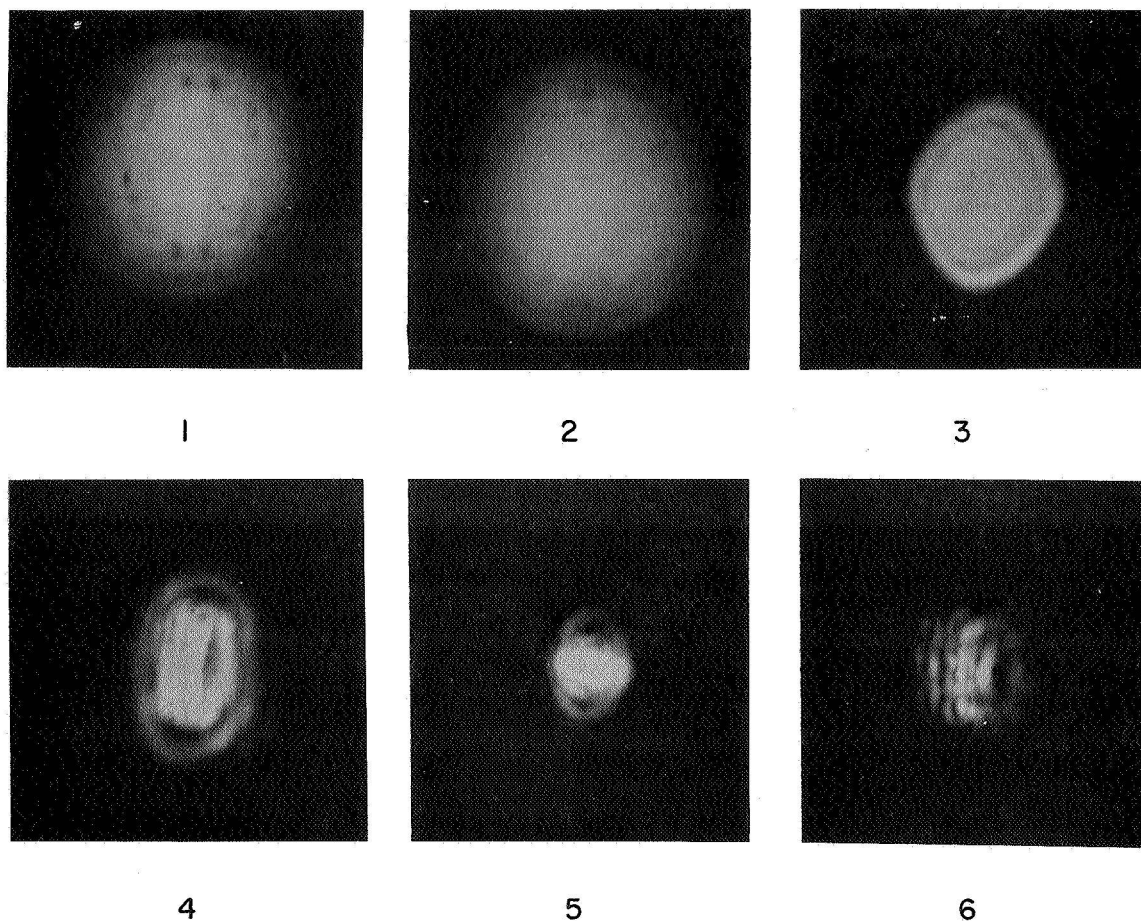
MODE DISTORTION OF ARGON LASER
(70 A Discharge)

- 1 Laser turned on 15 W output
- 2 After 1 minute 10 W output
- 3 After 5 minutes 9.3 W output
- 4 After 10 minutes 7.5 W output
- 5 After 20 minutes 6.5 W output
- 6 After 35 minutes 5 W output

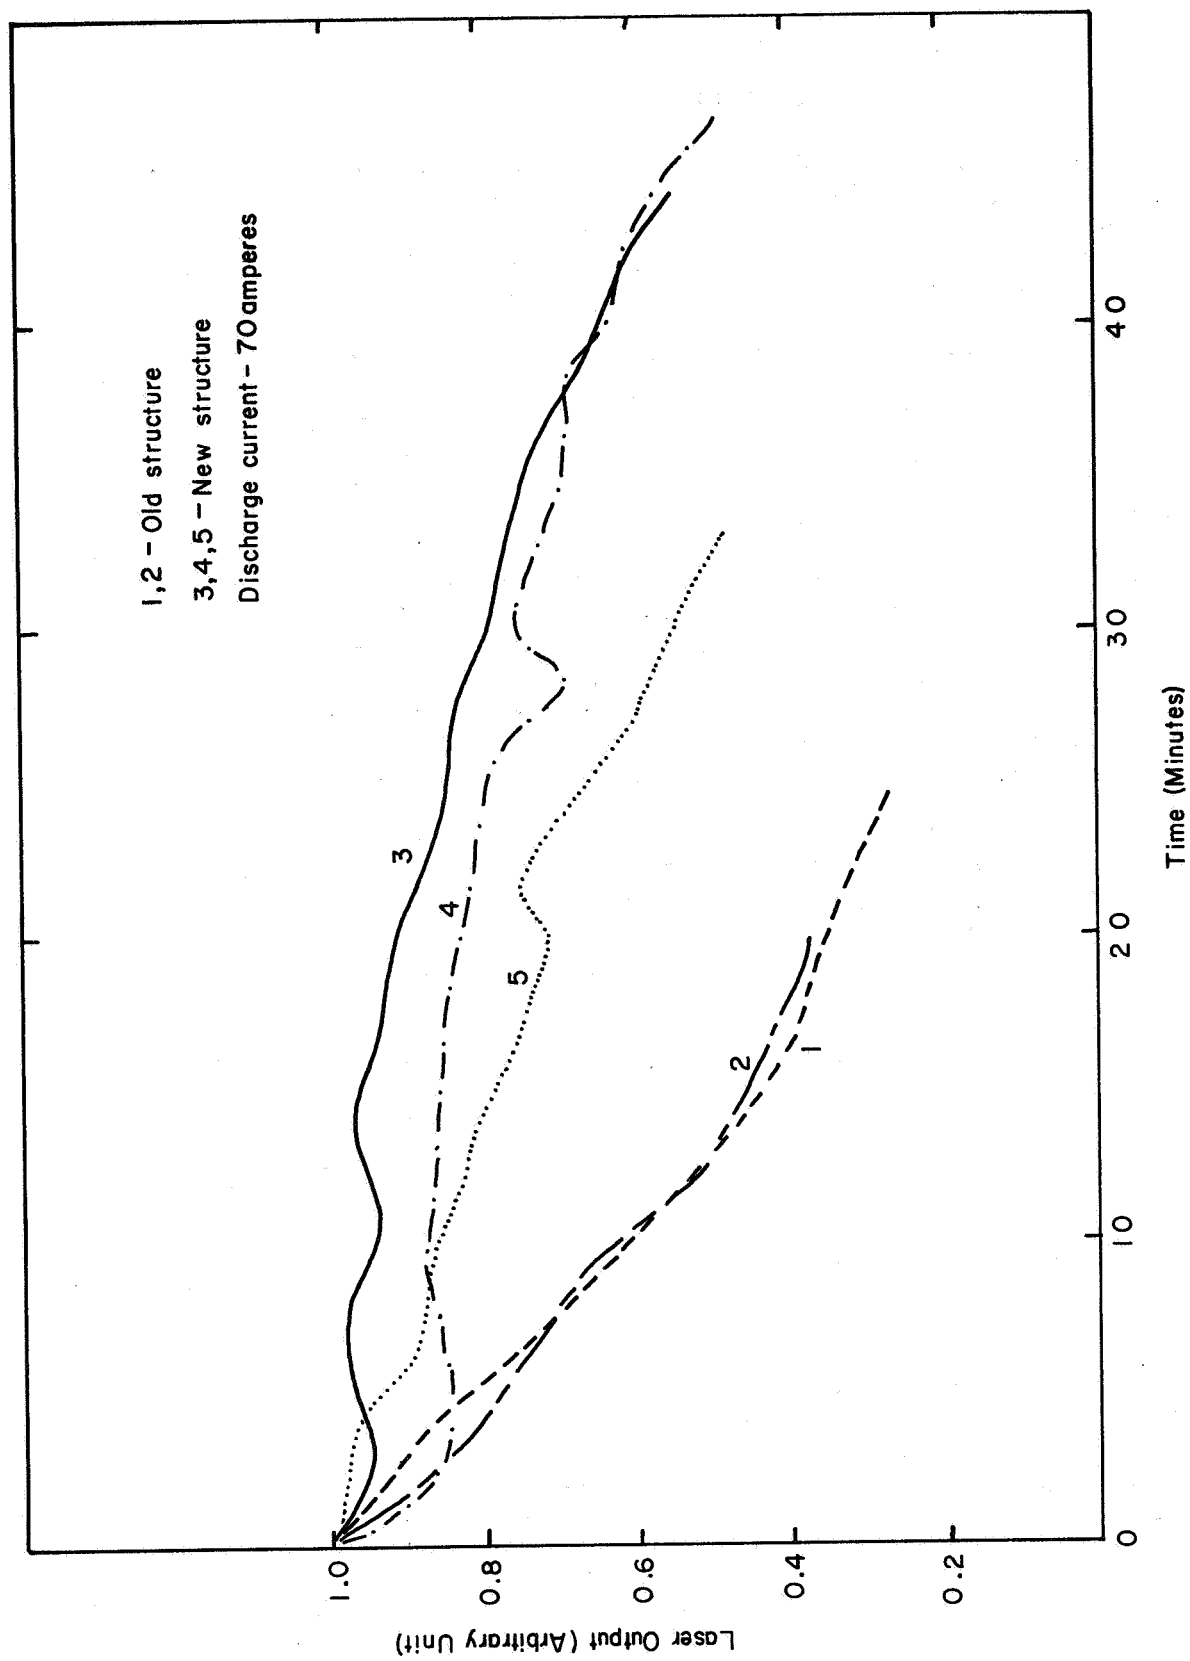
FIGURE 12

This relationship became evident when the discharge structure of the principal laser was replaced following a break in the bore of the initial structure. A substantial decrease in the decay rate was observed with the new structure, as compared with what had appeared to be the relatively stable rate of the old structure. In Fig. 12 normalized plots obtained with each structure are compared. Run 1 was obtained with the old structure just prior to tube failure, while run 2 was made a year earlier when that structure had been in operation a few months. Curves 3 and 4 represent runs made soon after installation of the new structure, and Curve 5 a run made a few weeks later. The increase in the decay rate of run 5 compared to the earlier runs 3 and 4 represents a structure aging effect which is better shown in Fig. 13. Here runs 1, 3, and 5 of Fig. 12 are replotted and relabeled O, A and B respectively; they are compared with an additional run C obtained six weeks after run B. It appears that the older the discharge tube, the easier it becomes to induce degradation of fresh windows. It should be noted that, during the six-week interval, between runs B and C, many hours of 70 - 100A operation were logged, much in contrast to the history of the earlier structure where such operating levels were quite limited in duration. This, no doubt is related to the reasons why the earlier structure exhibited such an apparently stable and history-independent, damage-inducing capability.

COMPARISON OF DECAY RATES OF LASER OUTPUT DUE TO WINDOW
DEGRADATION FOR OLD AND NEW DISCHARGE STRUCTURES.

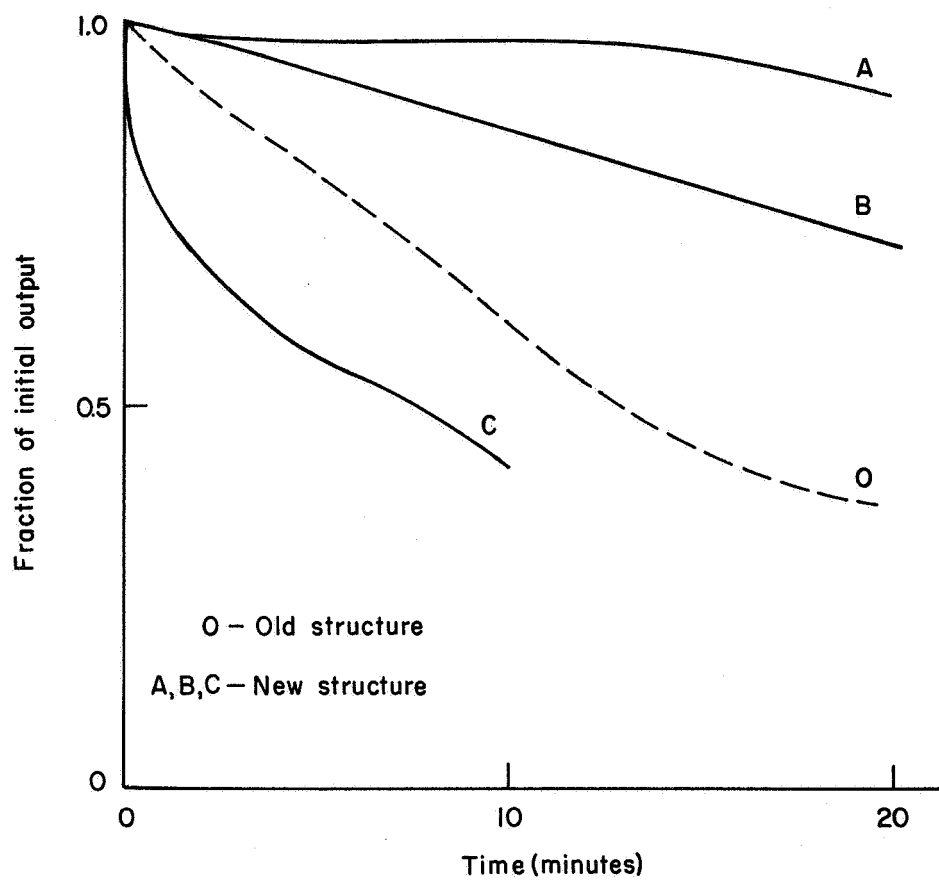
FIGURE 13

As was mentioned in the Introduction, wide variations in the rate of optical degradation have been noted among various discharge structures. Indeed, a range of power decay rates was observed for the principal laser under identical operating conditions. In particular, the decay rate showed an increase with the age of the discharge structure.

CHANGE IN OUTPUT POWER DECAY WITH
USE OF DISCHARGE STRUCTURE

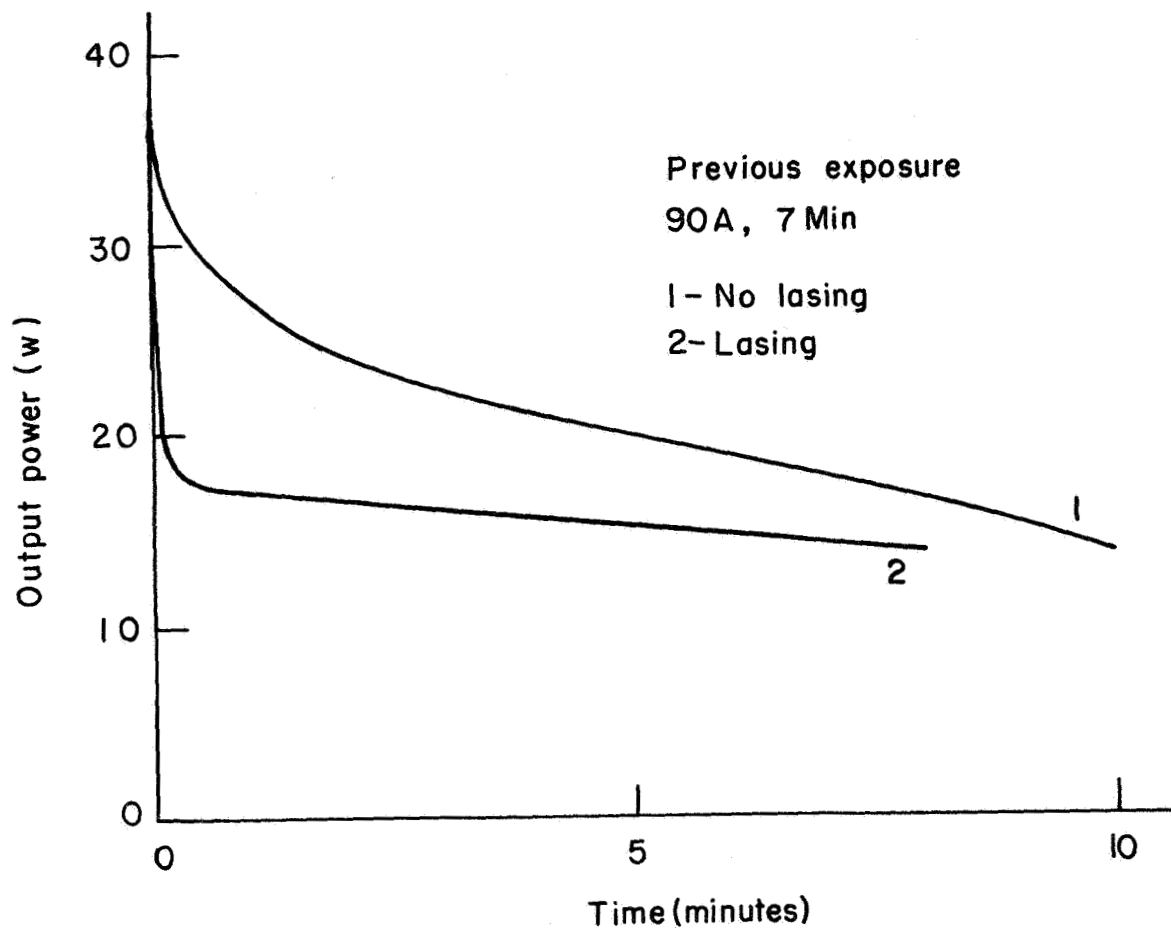
FIGURE 14

or nonpresence of the beam, prior window exposure was made at a higher discharge current (90 A) than that (70 A) used in the earlier tests. Figure 14 shows the relative effects of a seven-minute exposure to a 90 A discharge, lasing and nonlasing, on operation at the 70 A level. In this case there was evidently quite a difference between the lasing and nonlasing situations. The presence of the laser beam seemed to increase the damage rate significantly.

OUTPUT POWER DECAY USING WINDOWS PREVIOUSLY EXPOSED TO
LASING AND NONLASING DISCHARGE

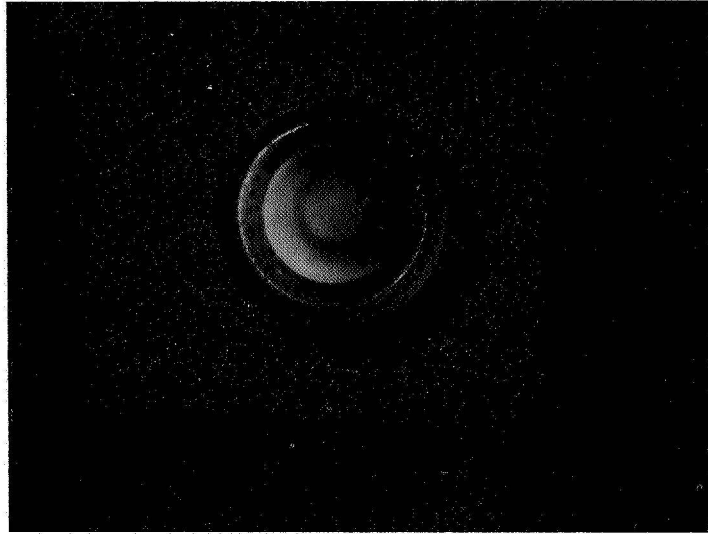
The other technique involved direct visual inspection of a breath-fogged surface. As the condensation begins to evaporate, well-defined patterns emerge. This differential rate of evaporation on the exposed surface is probably a result of variation in the surface thermal conductivity associated with film formation or local alteration in the surface structure. The "breath test" proved to be a simple criterion of window degradation and was particularly useful for assessing the effectiveness of different cleaning or window restoration techniques. An example of such a circular condensation pattern on an exposed mirror is shown in Fig. 15. Similar elliptic patterns were observed on Brewster windows but because of the very low contrast were difficult to photograph adequately.

Fig. 15 Fog Pattern Produced on Cooled Mirror
Surface After Exposure to Lasing Discharge

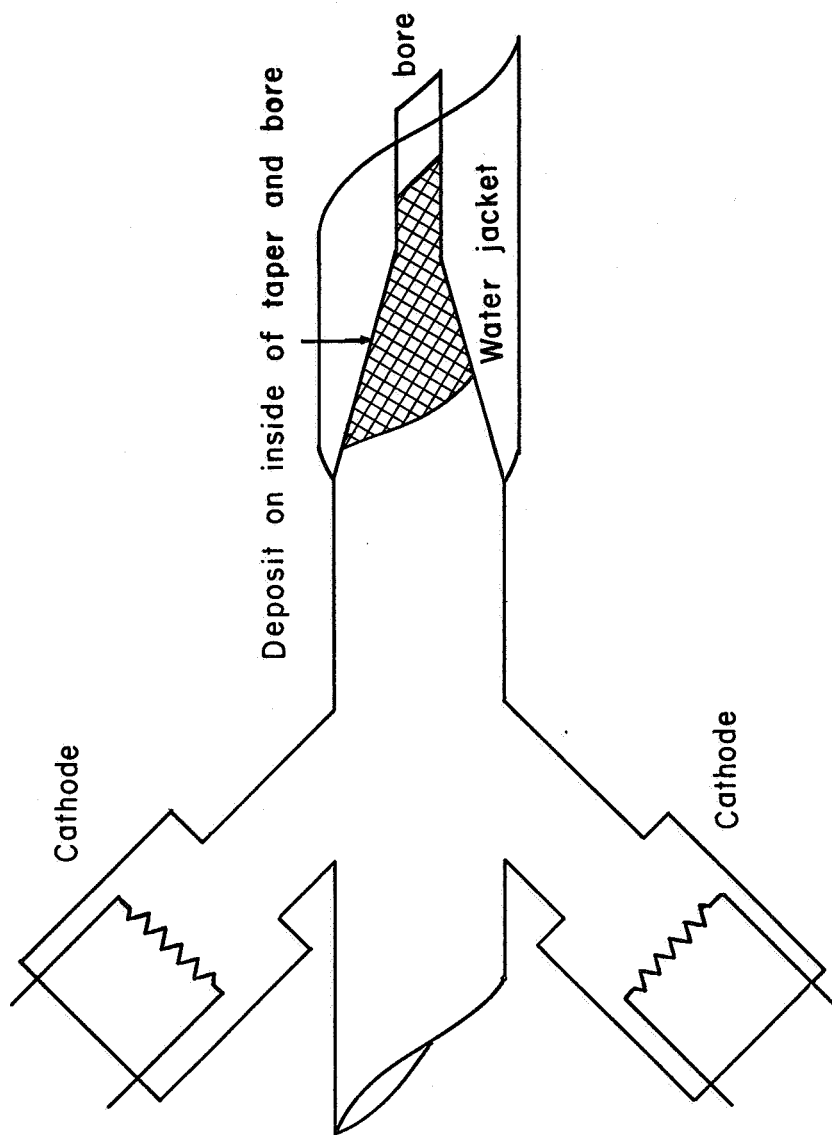
FIGURE 16

Inspection of the broken capillaries revealed darkened areas at various places. Microscopic examination of these areas showed that the quartz was badly eroded. The brownish color was found where the quartz seemed to have melted and resolidified. The discoloration was not on the surface but rather permeated glassy nodules and ridges on the quartz. The most severe bore erosion occurred adjacent to the tapered section. Here there was a spiral formation of alternating clear and dark bands; a scalloped erosion formed the clear regions, while the dark bands were made up of the discolored glassy nodules and ridges. A thick deposit of similar dark material was found on

LOCATION OF DEPOSIT AT CATHODE
END OF DISCHARGE TUBE

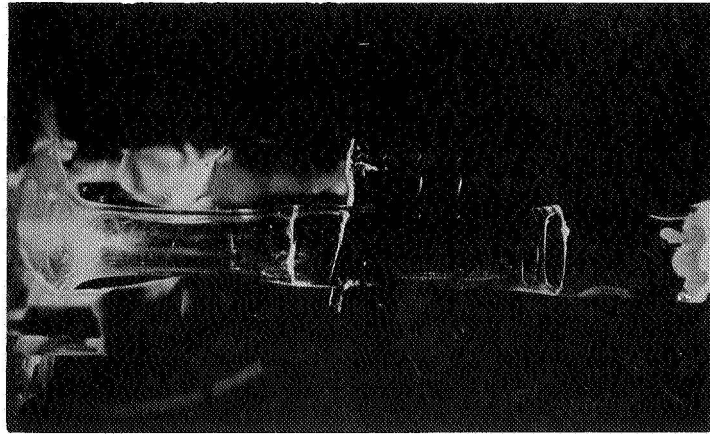
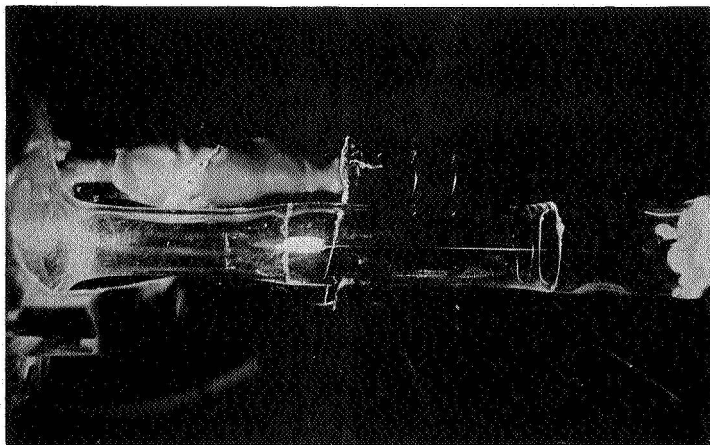
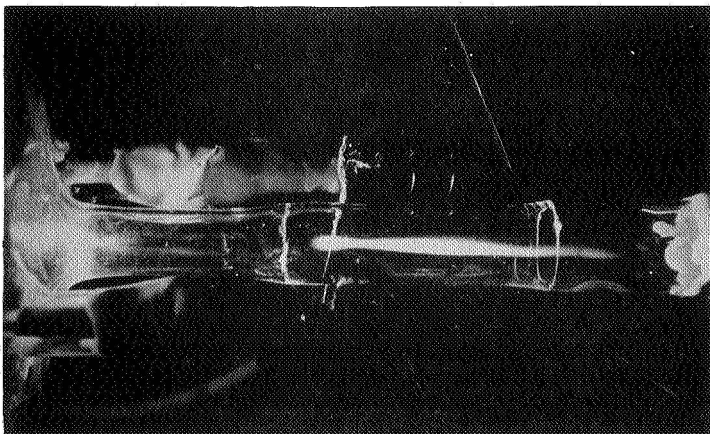
This particle transport is shown in the photos in Fig. 21 which view the section of the envelope between the anode bulb and the first bellows (B_1). In Fig. 21b the confined stream of particles and the terminating cusp formation are visible. The initial dispersal of the particles after removal of the ground connection is pictured in Fig. 21c. Similar particle behavior was noted at the cathode end of the structure when a potential of 200 V was established between the two bellows sections.

a) No potential gradient

b) Gradient established: Particle streaming

c) Gradient removed: Particle dispersal

Fig. 21 Particle Transport in the Region between the Anode and the End Bellows: Anode-Bellows Potential Difference 600V

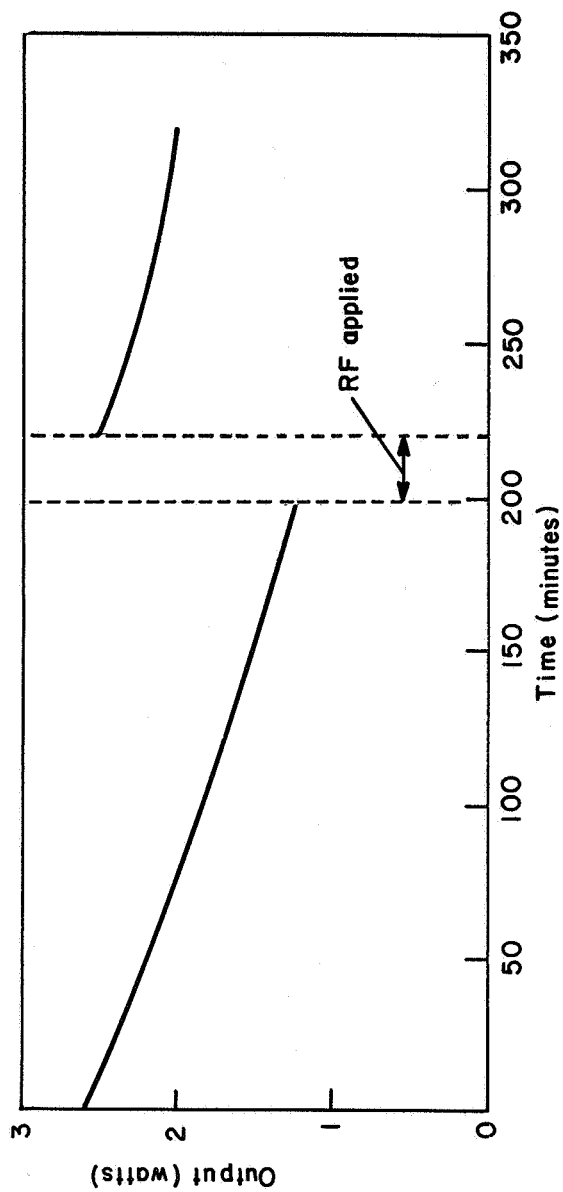
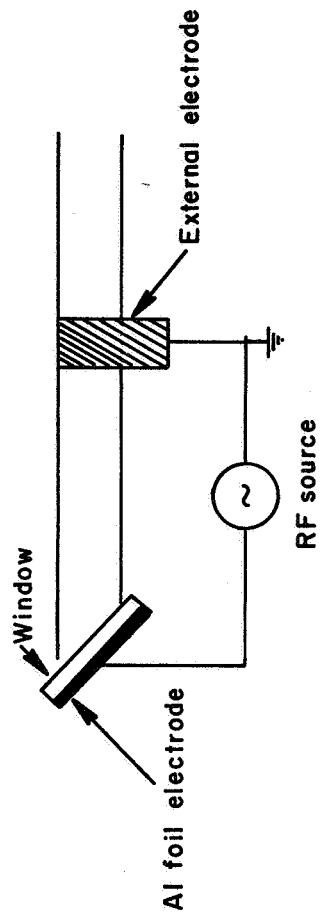
FIGURE 22

EFFECT OF ARGON SPUTTERING OF DEGRADED WINDOW ON OUTPUT
(PYROLYTIC GRAPHITE BORE LASER; ARGON PRESSURE 450 MTORR)

In further tests, film removal by argon sputtering proved to be quite effective even with normal gas fill pressures. Degraded windows located at either the cathode or anode end of the laser structure were restored by this means. These results were obtained for the pyrolytic graphite bore laser (Fig. 22) as well as the principal laser. Later it was determined that the sputtering could be accomplished using a Tesla coil as the rf source. Although the windows were restored to their original condition by the sputtering action, renewed film deposition commenced soon after the sputtering ceased. Additional tests with Tesla coil applications of the rf to the region of the mounting tube away from the window while the laser was operating showed that, not only was film removal accomplished, but also that film regrowth was somewhat inhibited.

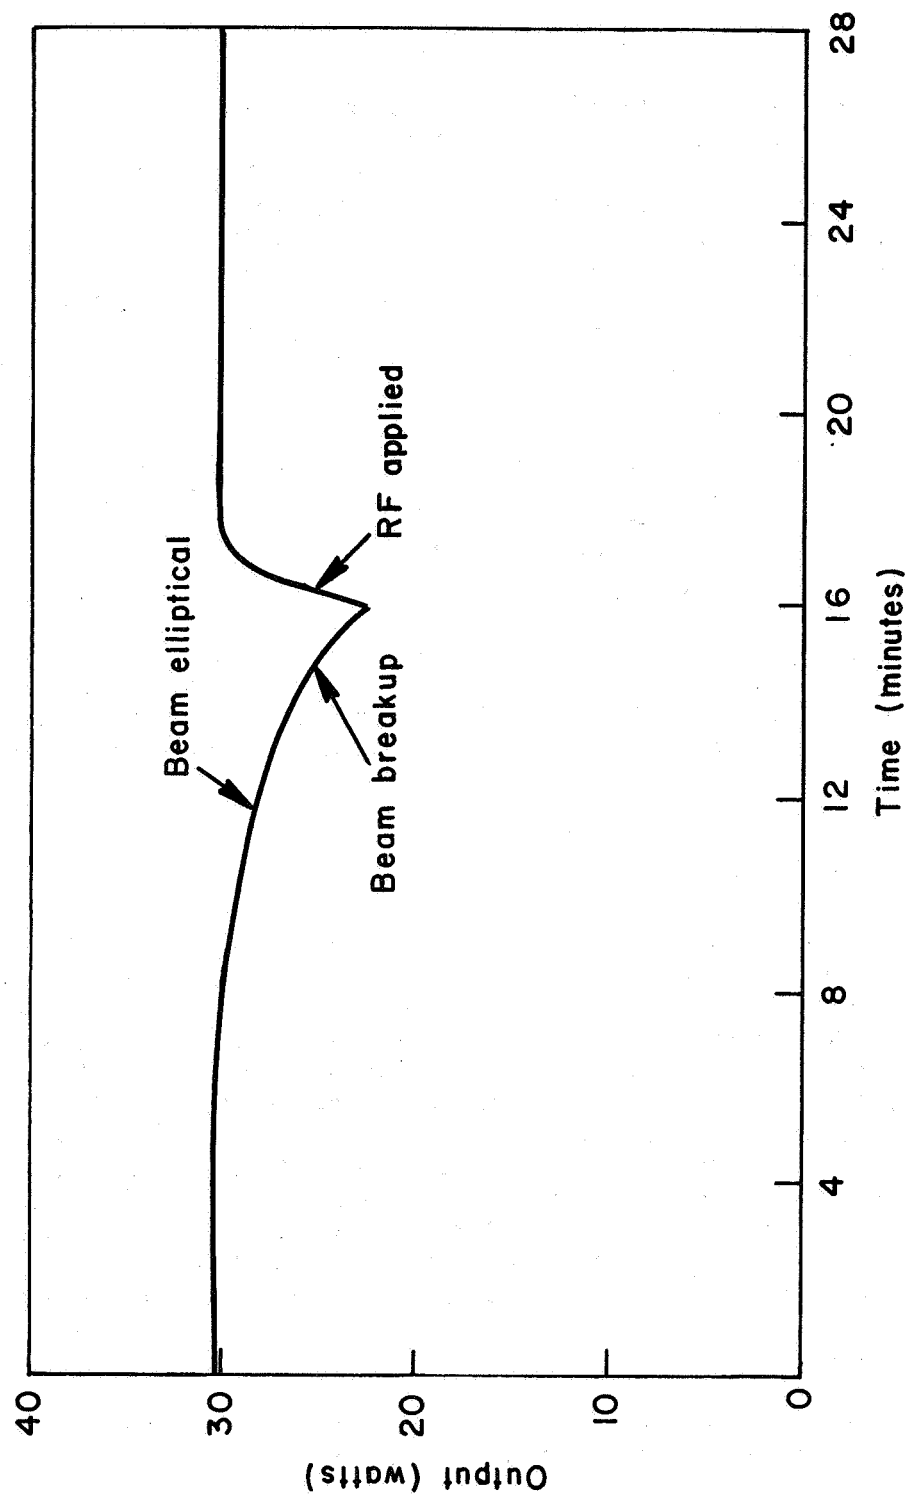
FIGURE 24

EFFECT OF RF DISCHARGE ON OUTPUT (PRINCIPAL LASER)

This result was followed up using a more refined method establishing the rf discharge, in which the rf was applied between an external electrode around the tube, located a few centimeters from the window, and the flange while the laser was operating as is shown in Fig. 23. A dramatic cleanup of the window (Fig. 24) was observed within the first minute after initiating the rf discharge. Further tests with the rf technique, which had no adverse effects on the output during the application time, indicated that re-establishment of the window film was inhibited particularly with high discharge current and high optical power operation.
